# Manhole Inspection Summary

Manhole # S35QQ\_043MH

Insp Date: 1/23/07 9:06 AM

**Location** Address: **2435 SAINT PAUL ST**

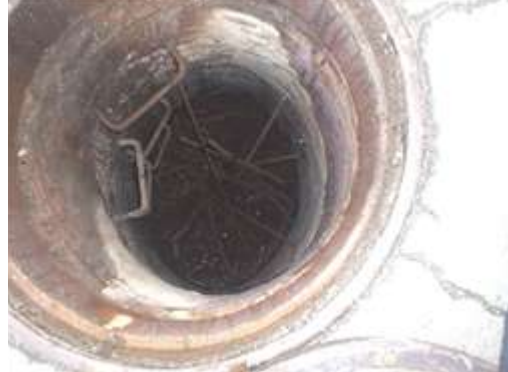
Top View

Channel debris.

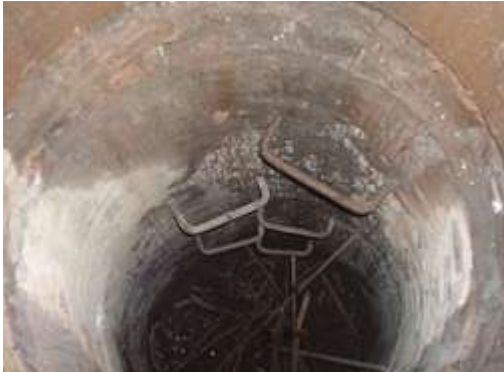
Defect

Frame leaks. Adjustment deterioration, loose brick and infiltration. Barrel infiltration.

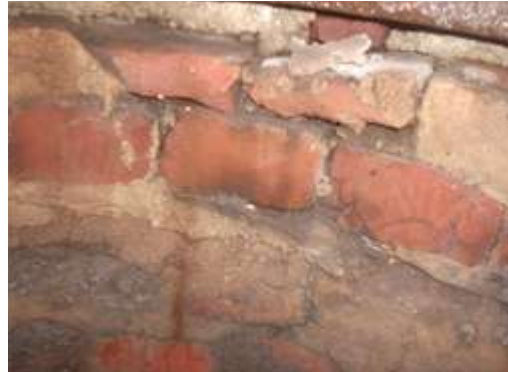
Defect

Frame leaks. Adjustment deterioration, loose brick and infiltration.

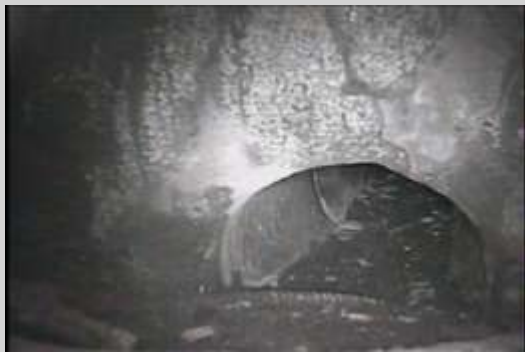
8 in. Circular Gravity Sewer  
Pipe Out @ 12 O'Clock

Deposits: ☐ None ☒ **Mud** ☐ Sludge ☒ **Debris** ☐ Grease

Silt Depth: **2** (in.) Deposits Extent: **Light**
